An Investigation Of The Causes And Recommendations For
Correction Of The Pinole Slipout, Road 04-CC-80

June 1969

AN INVESTIGATION OF THE CAUSES
and
RECOMMENDATIONS FOR CORRECTION
of the
PINOLE SLIPOUT
ROAD 04-CC-80

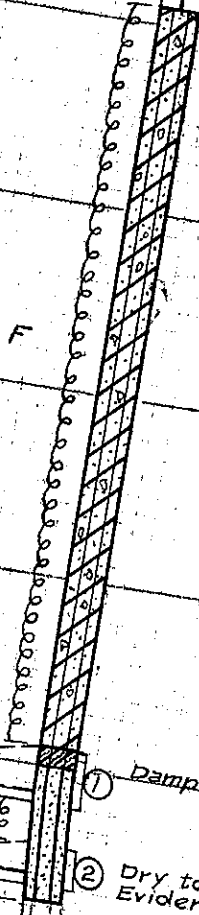
Profile of Boring D-1

Damp, firm, yellowish-tan, sandy silty clay with some gravel, MP
Fill material

① Damp, stiff to hard, black silty clay - HP - Organic

② Dry to damp, hard, light grayish tan, fine sandy silt, NP to SP
Evidence of carbonates.
